REPORT
ON
THE FLOODS OF THE MOIRA RIVER,
AT
BELLEVILLE, ONT.

APRIL, 1920.

WALTER J. FRANCIS & COMPANY
CONSULTING ENGINEERS
MONTREAL.

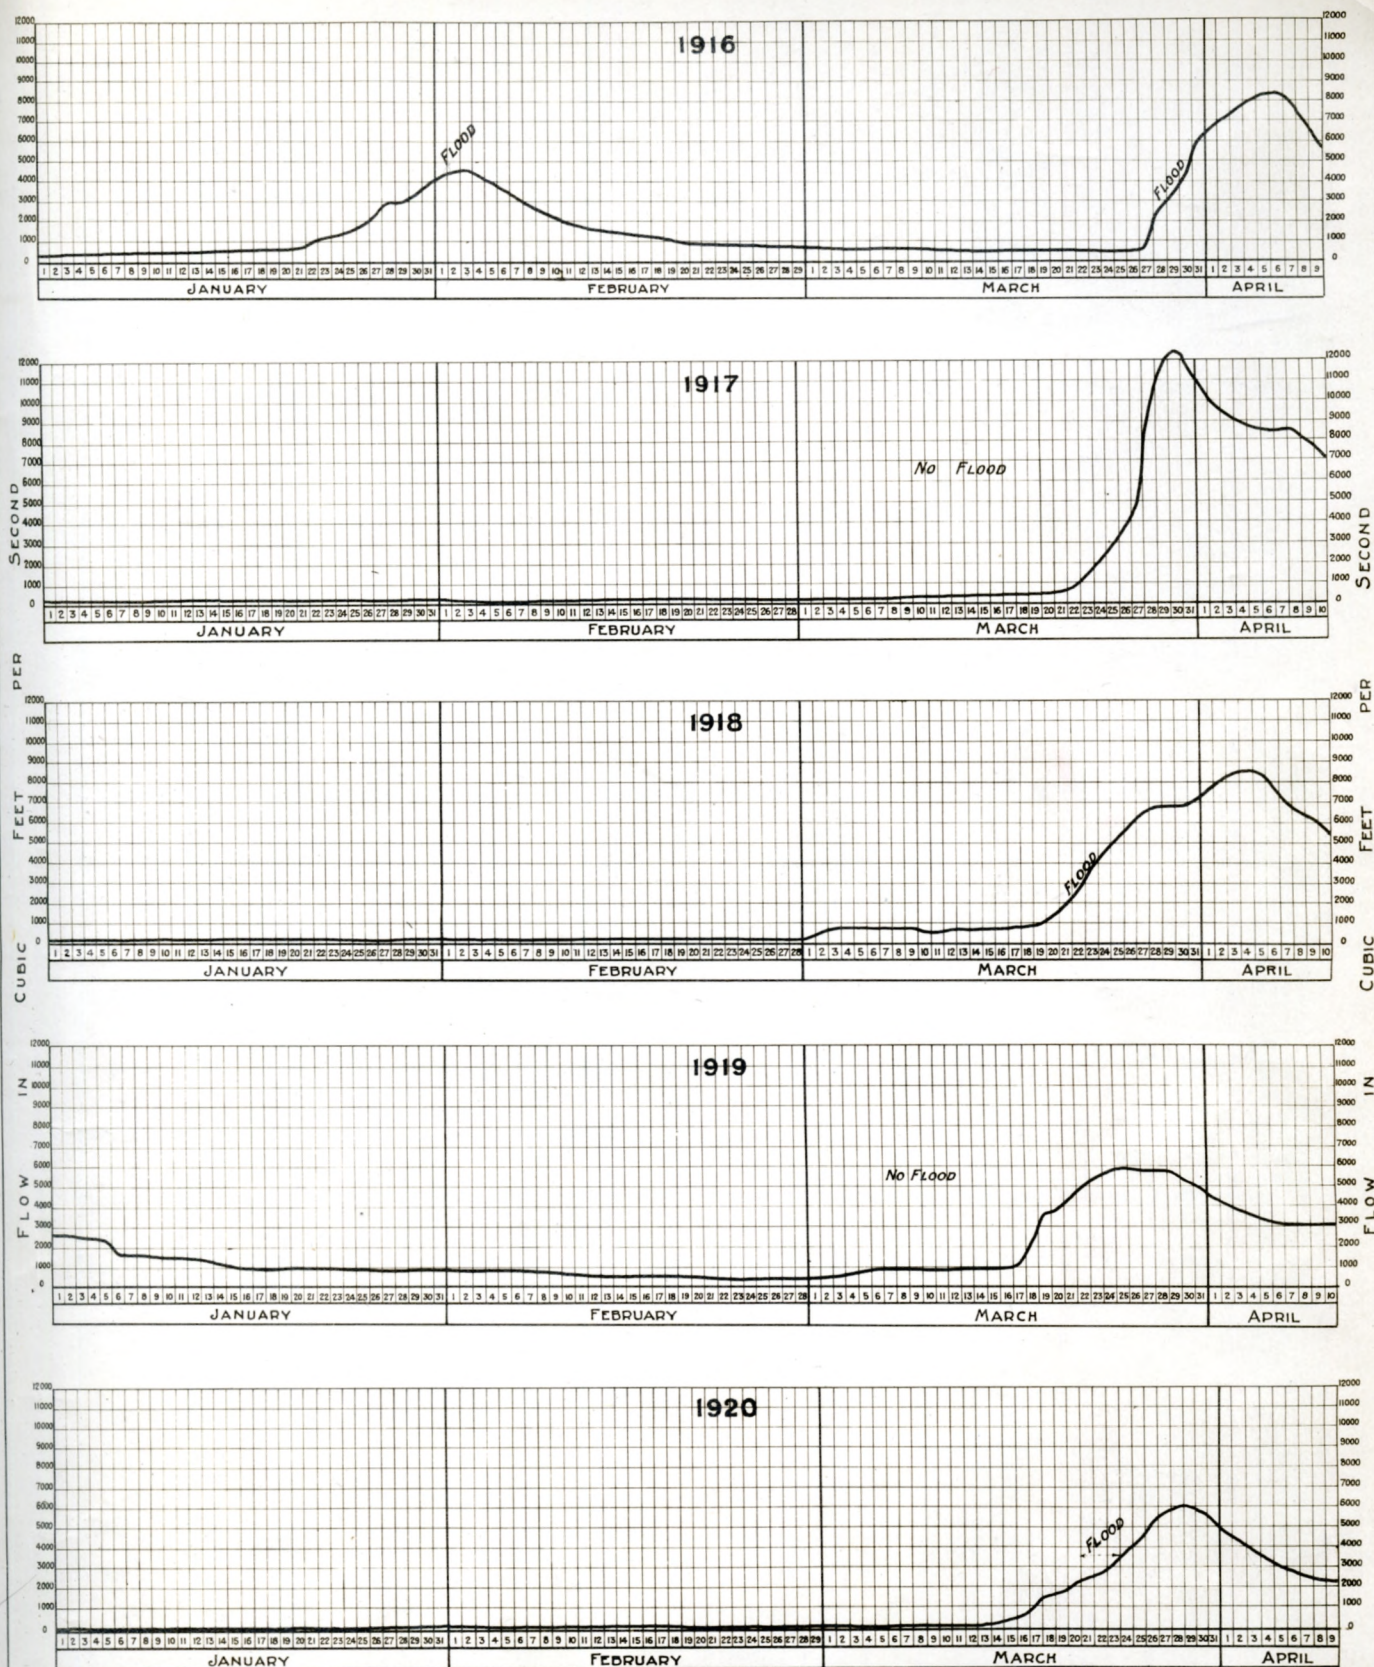
MOIRA RIVER, BELLEVILLE, ONT.
 DISCHARGE IN CUBIC FEET PER SECOND
 JANUARY 1ST TO APRIL 10TH OF THE YEARS
 1916 TO 1920

per second throughout February and the first week in March, rising to 300 cubic feet per second by March 10th and to 400 cubic feet per second by March 14th. The daily flow is shown on the diagram included as page 4.

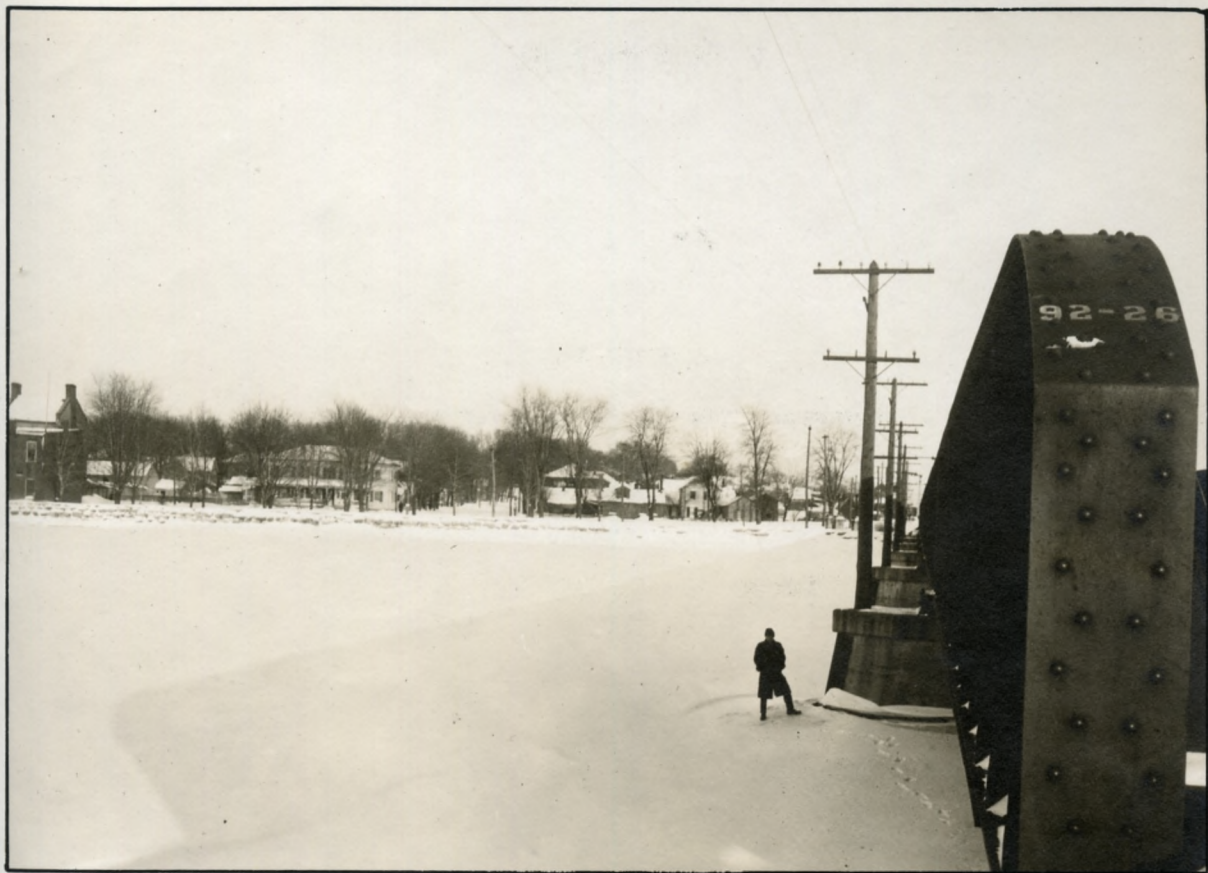
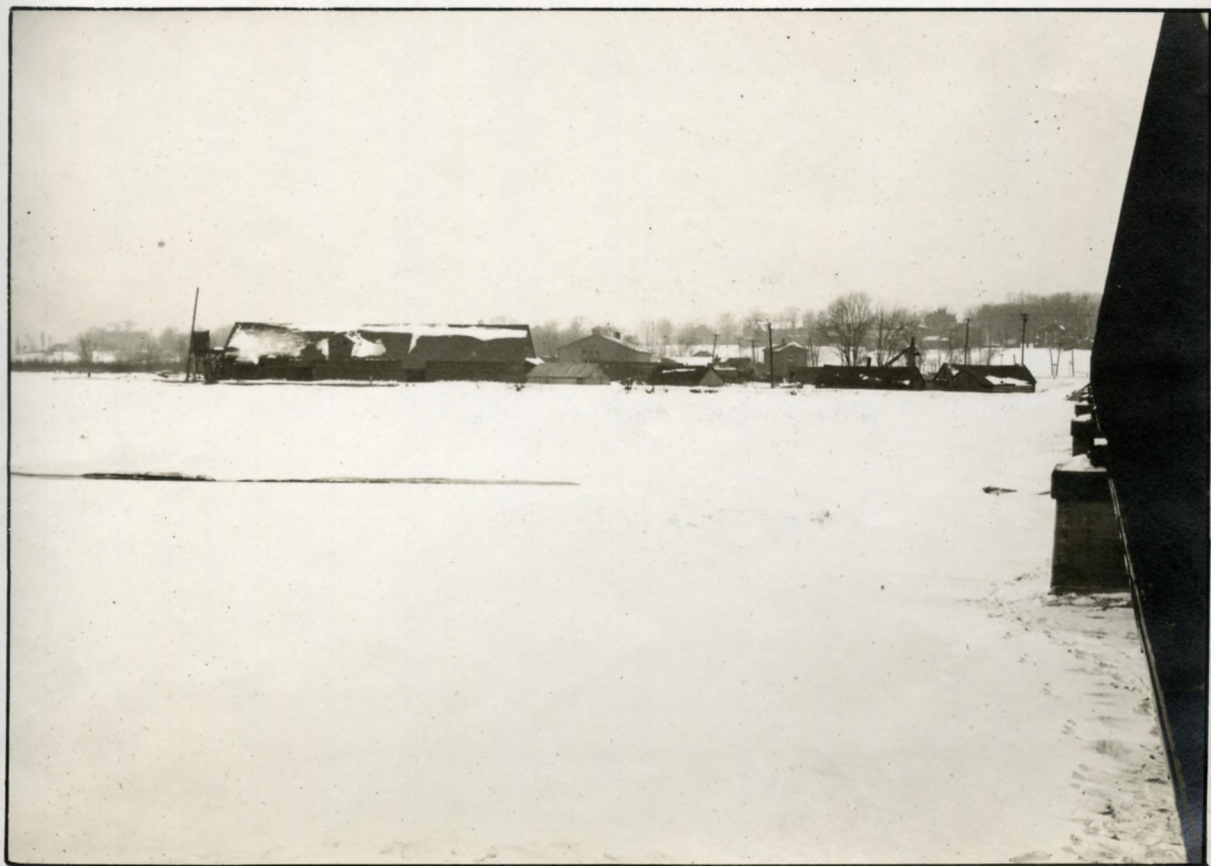
Photographs Nos. 3 and 4 included as page 10, show the upstream and downstream sides of the Railway Bridge in typical mid-winter conditions, while No. 5, included as page 11, shows the downstream side of the Railway Bridge looking upstream.

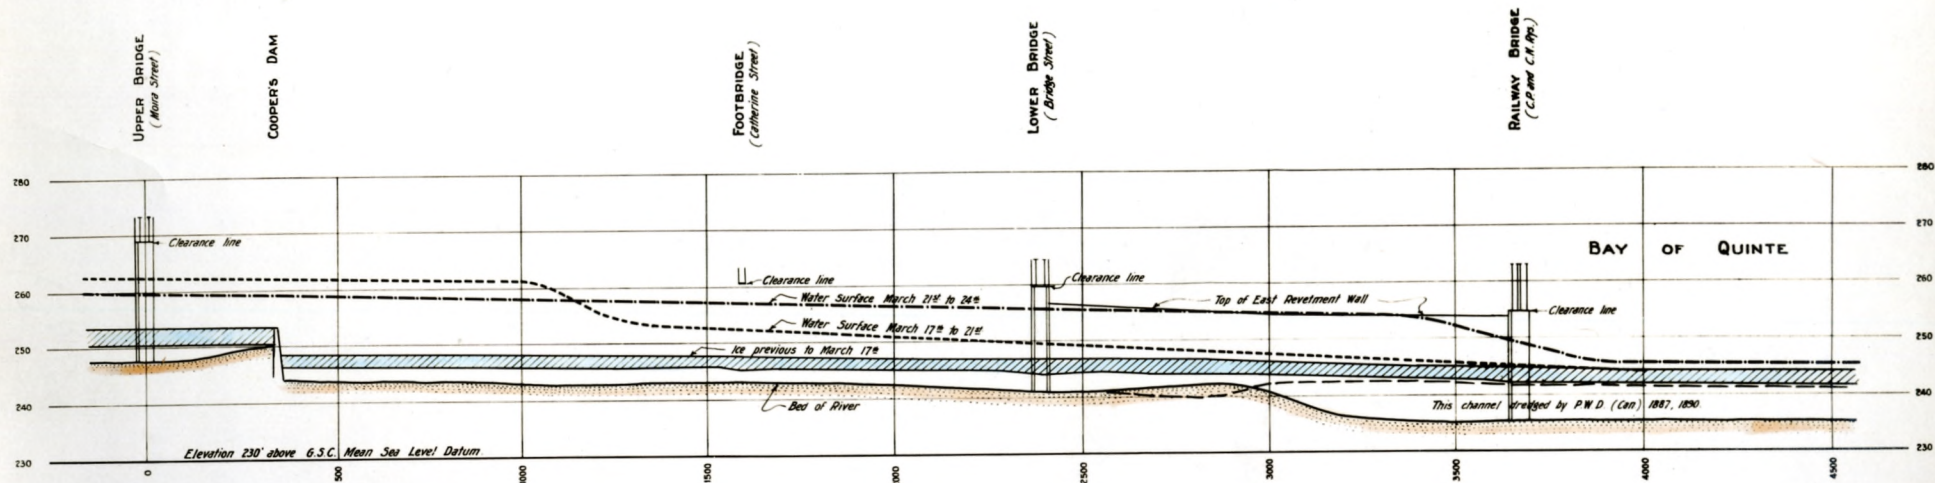
MOIRA RIVER, BELLEVILLE, ONT.
PROFILE OF RIVER THROUGH BELLEVILLE
 SHOWING VARYING CONDITIONS DURING
MARCH 1920

at the Upper Bridge rose about 6 feet, as shown on the profile on page 13. The east side of the jam rested on a low narrow island in the river, and the water was enabled to escape from the side of the jam through the narrow channel between this island and the easterly bank. The water was raised sufficiently to pass over the concrete wall near the vulcanizing works south of the Upper Bridge, flooding the garage on the lower floor, and at the same time there were some cellars and basements in the upper end of the city slightly flooded. Below the front end of the shove the surface of the ice was broken and buckled to a point about 100 feet below the Foot Bridge, permitting the water to flow over the surface in many places, and open channels were forged as far south as the Lower Bridge, below which point there was little change from former conditions. The flow at this time averaged 1,380 cubic feet per second.

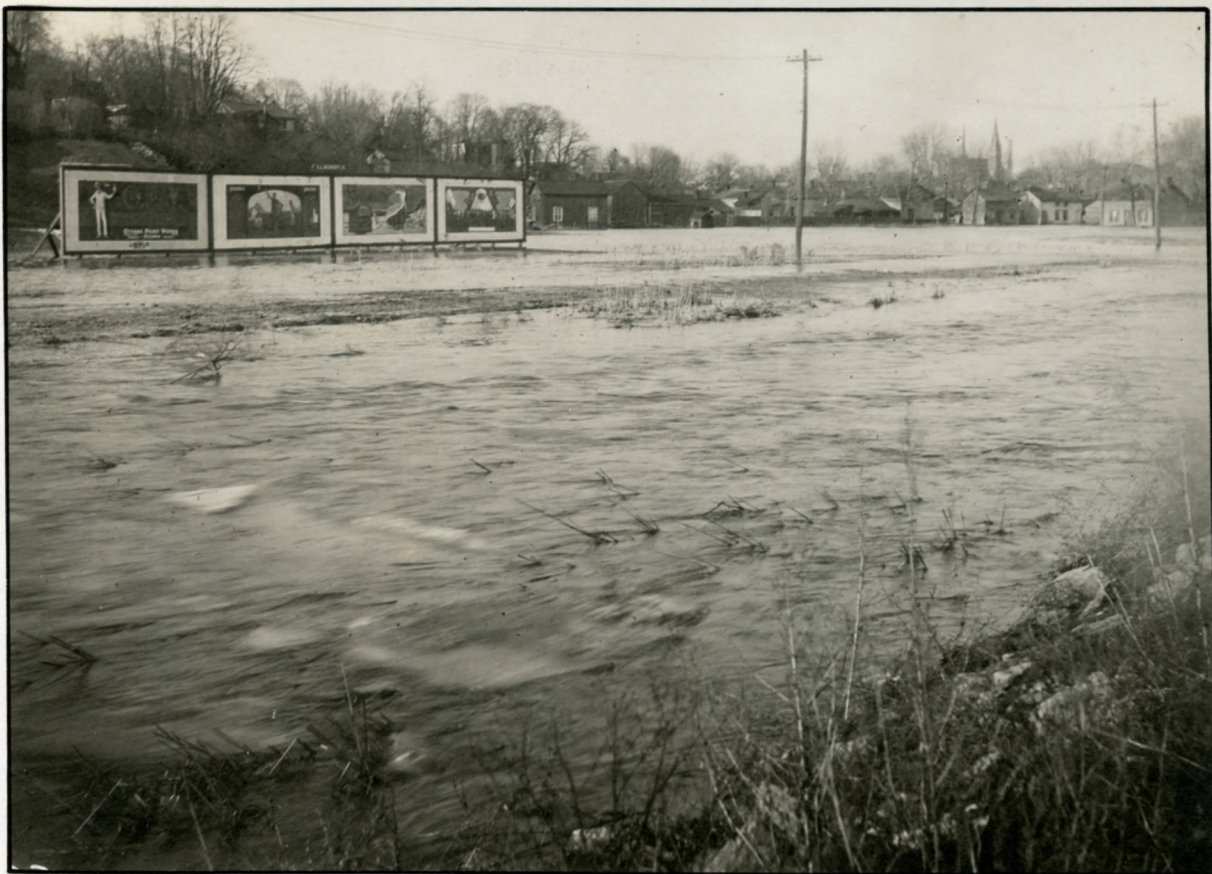
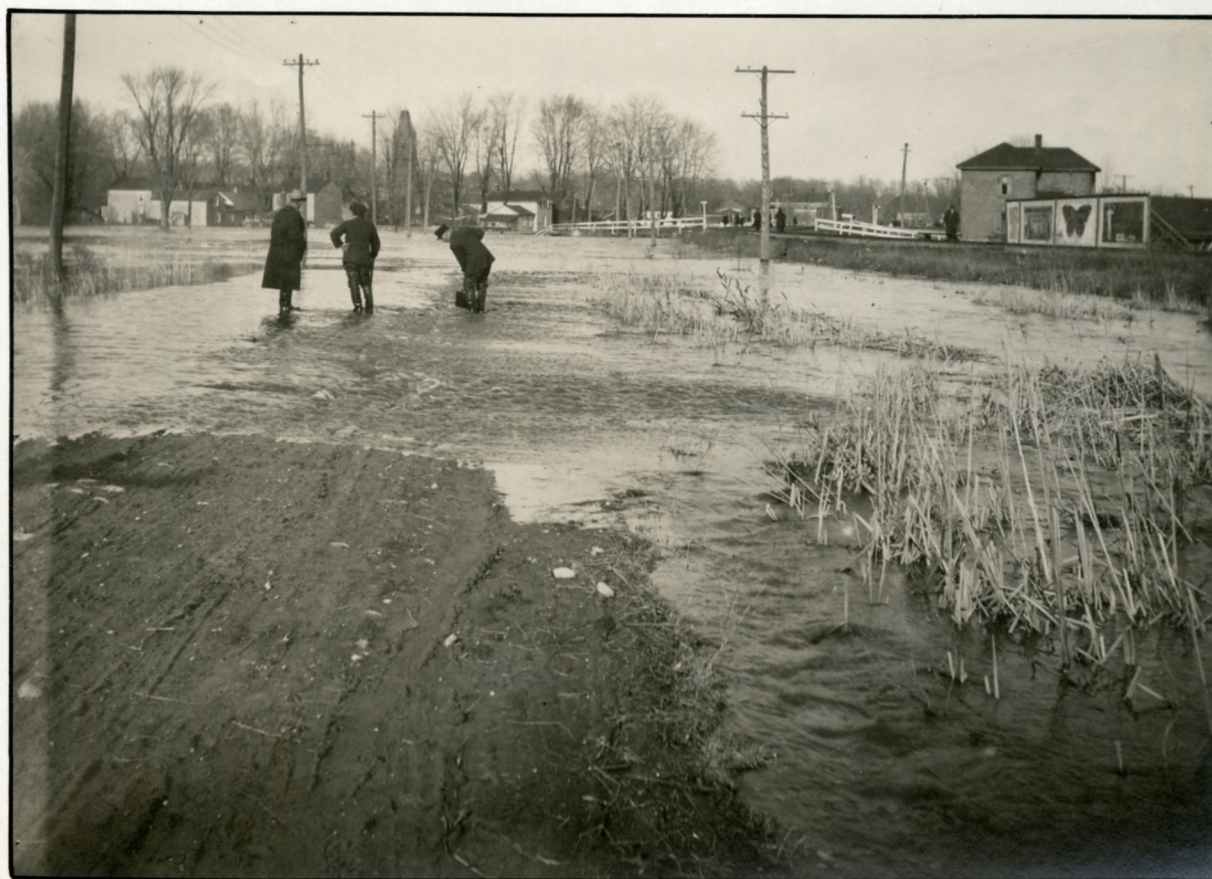
The water in the new culvert at Bay Bridge Road never rose higher than Elevation 249.6, or within 1.8 feet of the underside of the girders. Photo-

graphs Nos. 18 and 19 on page 30, showing this culvert, were taken during the height of the flood.

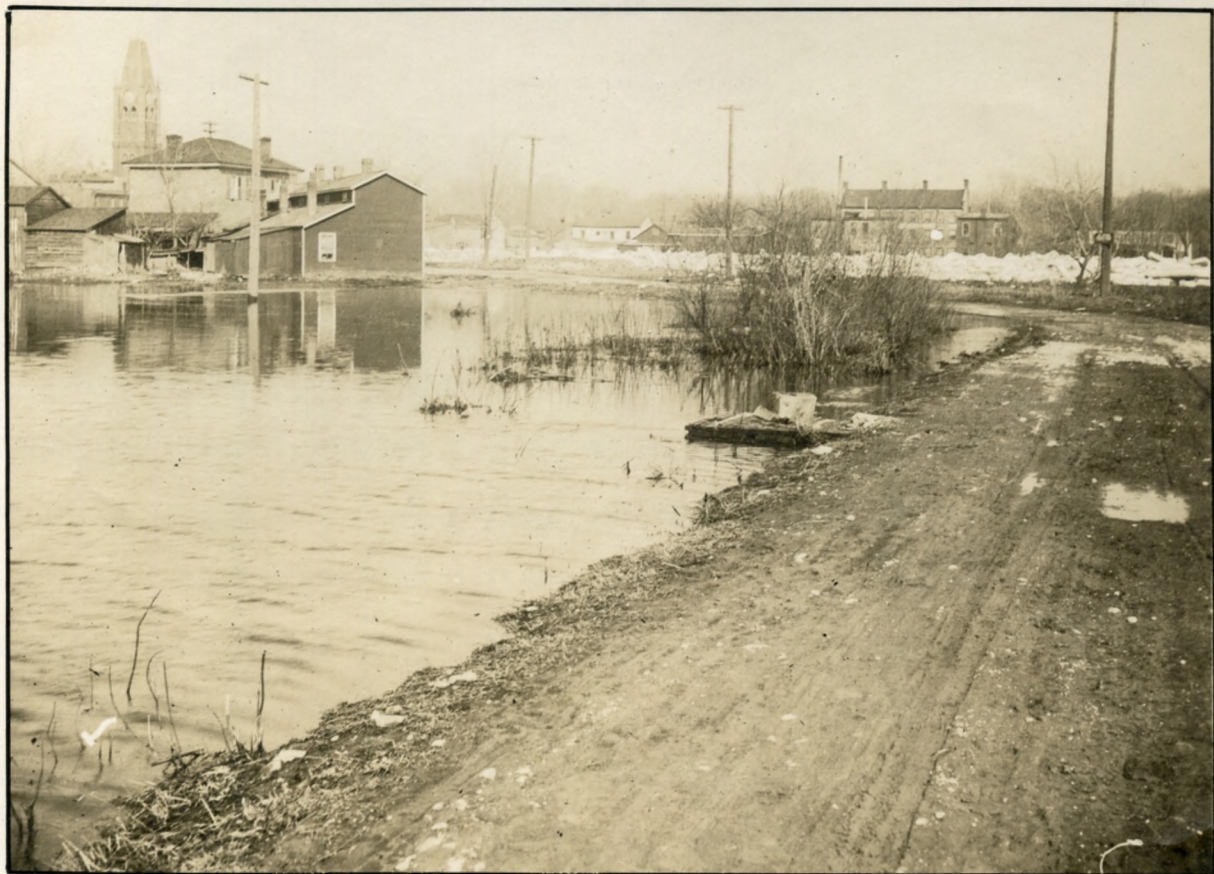
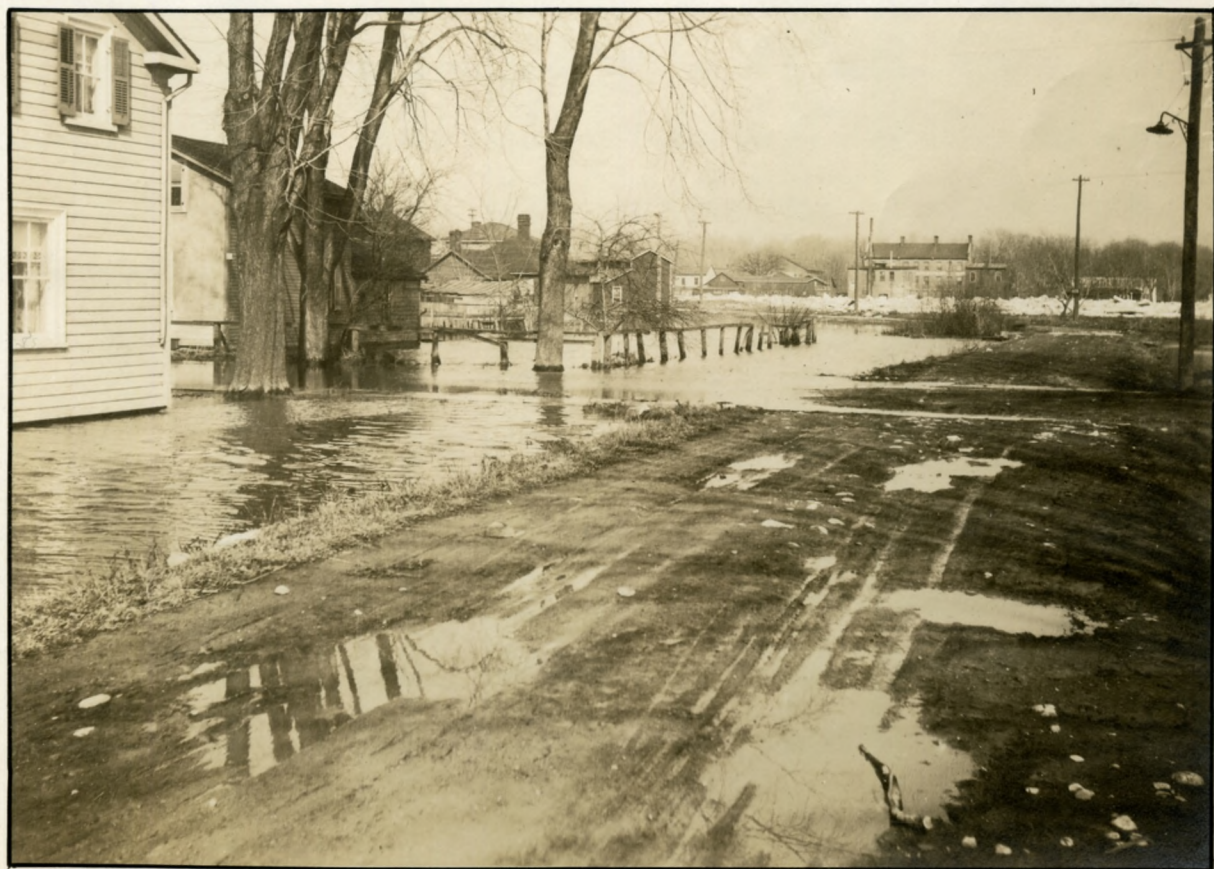
Photograph No. 24.

On this same date, namely, March 22nd, the water in the flooded area on the west side of the river, south of Bridge Street, receded considerably and no longer flowed over Dundas Street. The general condition in the neighbourhood of James, Dundas and Water Streets is shown in photographs Nos. 24 and 25, included as page 34.

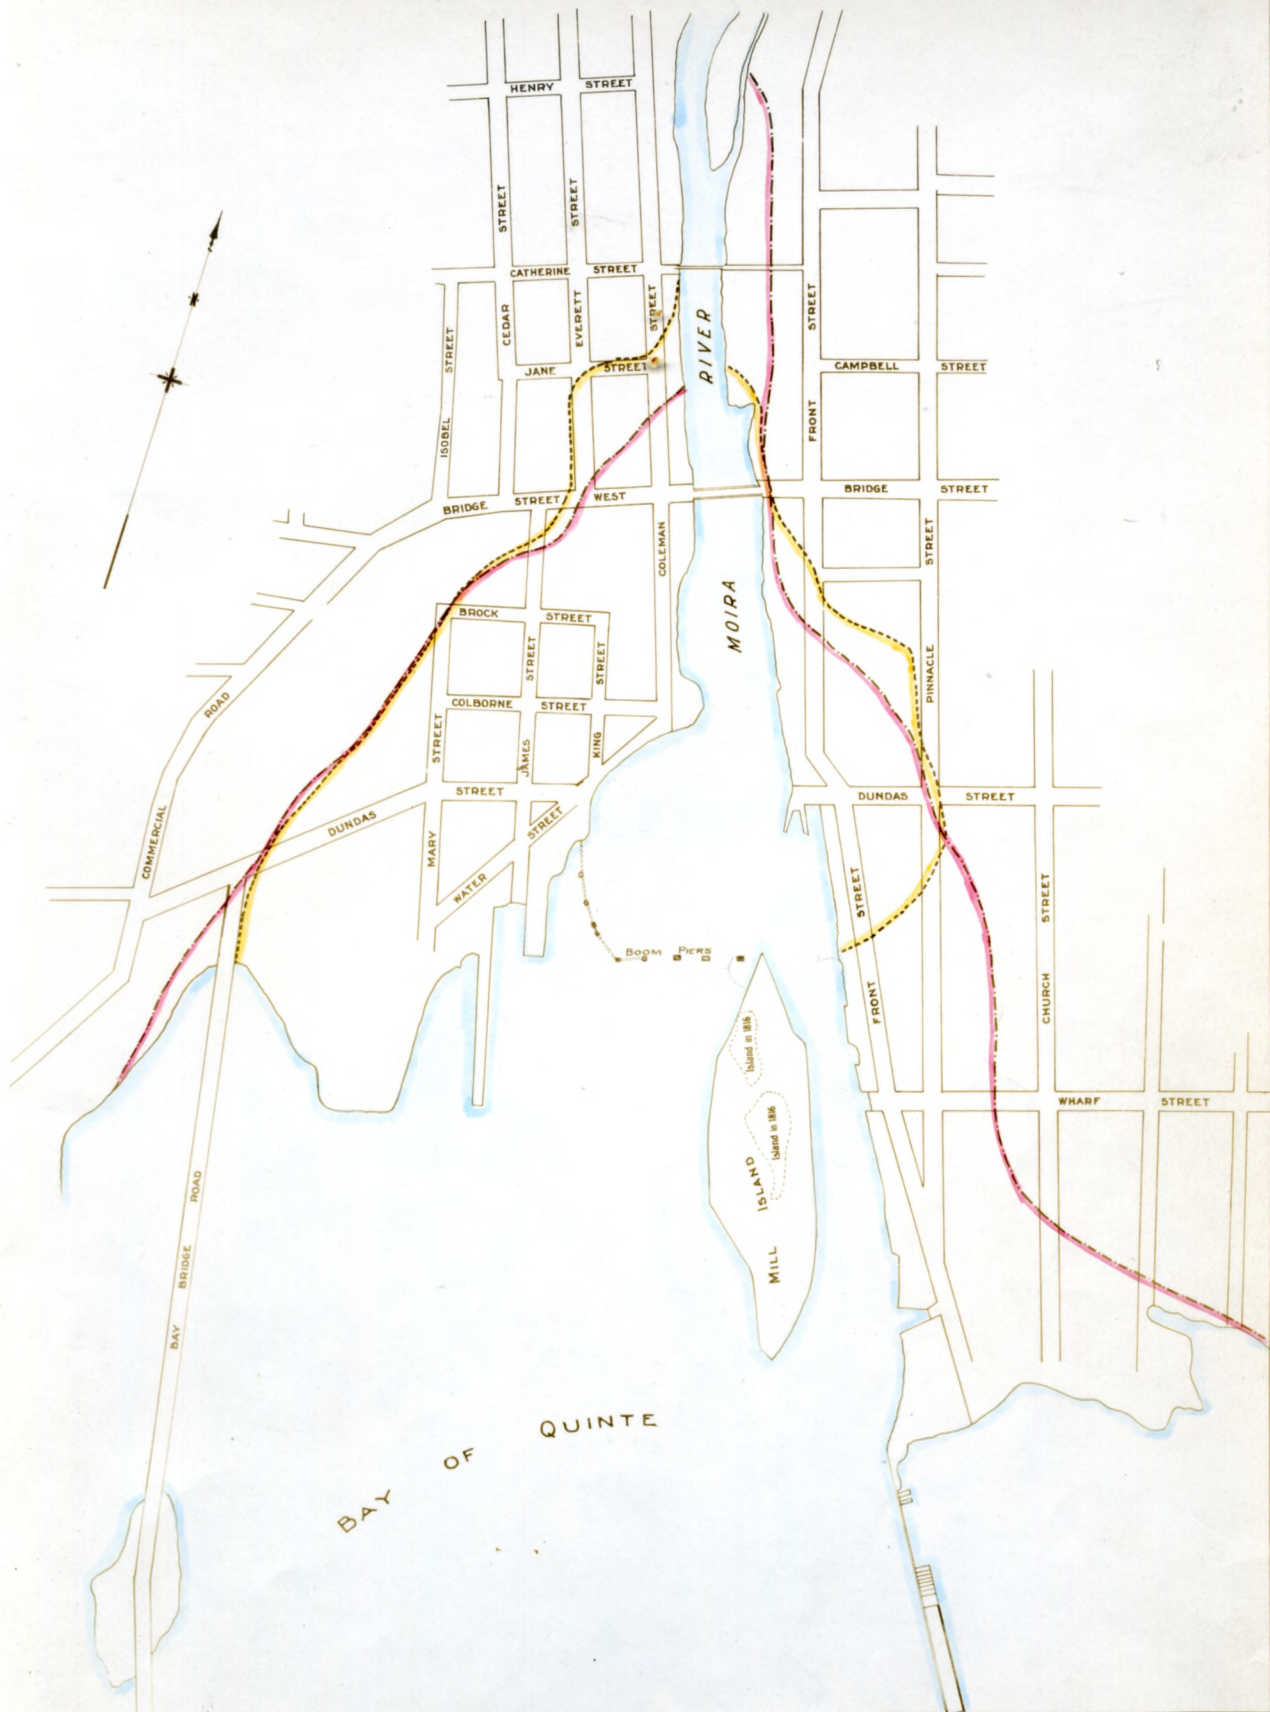
MOIRA RIVER, BELLEVILLE, ONT.
PLAN SHOWING LIMITS OF FLOODING
IN YEARS 1886 & 1891

Limit of Surface Flooding in March 1886 shown thus
 " " " " " January 1891 " "
